**W. Jeff Koskie**  
***Pipeline Safety and Compliance Manager***  
555 W. Fifth Street, M.L. GT-11A6  
Los Angeles, CA 90013  
Phone: 213 305-8660  
Fax: 213-244-8223

Attachment 1  
Response to Audit Findings

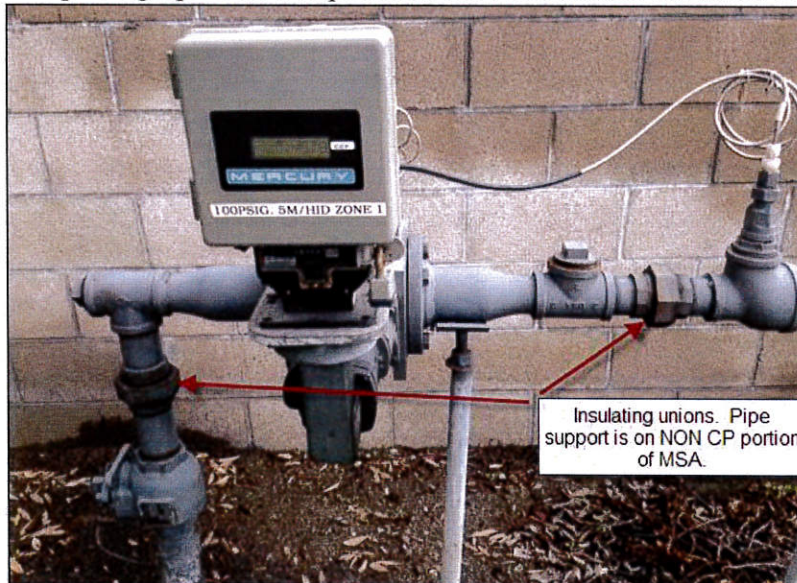
### Documents supporting response to Finding #4

CPSD inspected the piping from the meter-set-assembly (MSA) at the Anaheim district base and determined that the MSA was not properly insulated from its anchor as required by Title 49 CFR §192.467(b). Please describe the action the Region engaged in to correct this violation.

This meter set is properly isolated per the requirements of 49 CFR 192.467(b). Therefore there is no violation.

49 CFR 192.467(b) requires the installation of insulating devices “where electrical isolation of a portion of pipeline is necessary to facilitate the application of corrosion control.” The piping identified by Staff does not require insulation per this code section. The support in question is located on an above-ground pipe segment located downstream of an insulating union separating it from the upstream cathodic protection system. This portion of the MSA is electrically isolated from the upstream piping so as not to interfere with the application of cathodic protection on the upstream CP system. As a result, the support does not impact the cathodic protection system in any way. Therefore, the insulation requirement in section 192.467(b) does not apply.

The photograph below represents the condition of the MSA in question at the time of the audit.

As we are in compliance with 49 CFR 192.467(b), there is no violation and no further action is required.

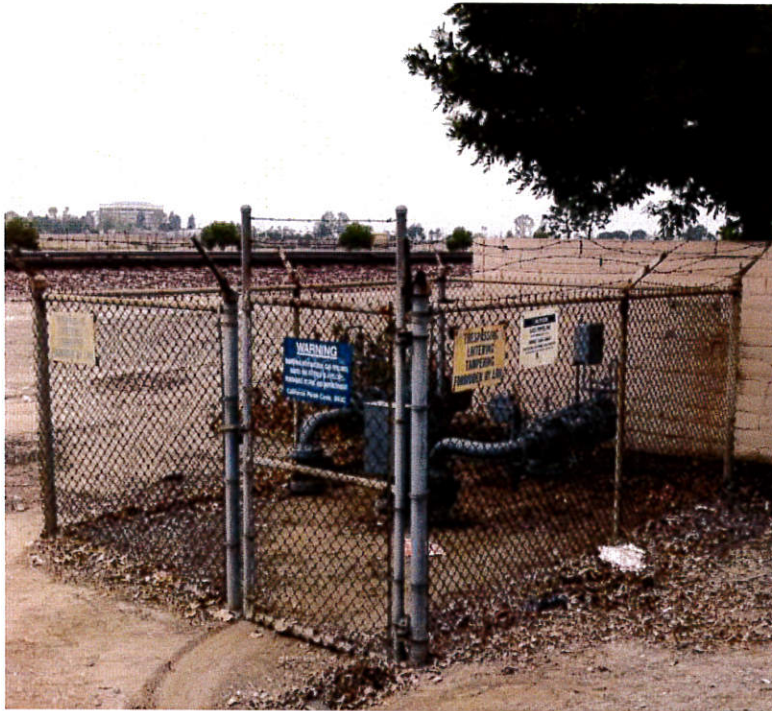
CPSD inspected regulator stations in Anaheim (Orangethorpe and Rose) and Fullerton (Raymer and Gilbert) and noted that there were no aboveground markers as required by Title 49 CFR §192.707(c). Please explain why the pipeline markers were missing and advise CPSD on the action taken by the Region to correct these violations.

The two identified regulator stations are fenced, barb-wired, and locked. As such, these areas are not accessible to the public. Accordingly, the above mentioned facilities do not violate 49 CFR 192.707(c), which expressly applies to facilities “accessible to the public.”

Orangethorpe and Rose DRS, the day after CPUC inspection.

Although there was no violation, we installed new signage at the two sites identified during the inspection.

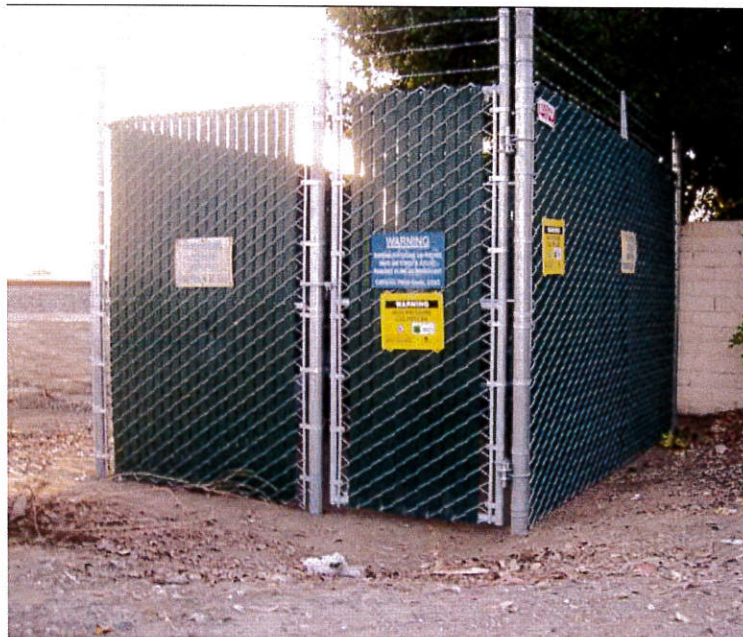
Orangethorpe and Rose DRS - Shows recent fence replacement and signage

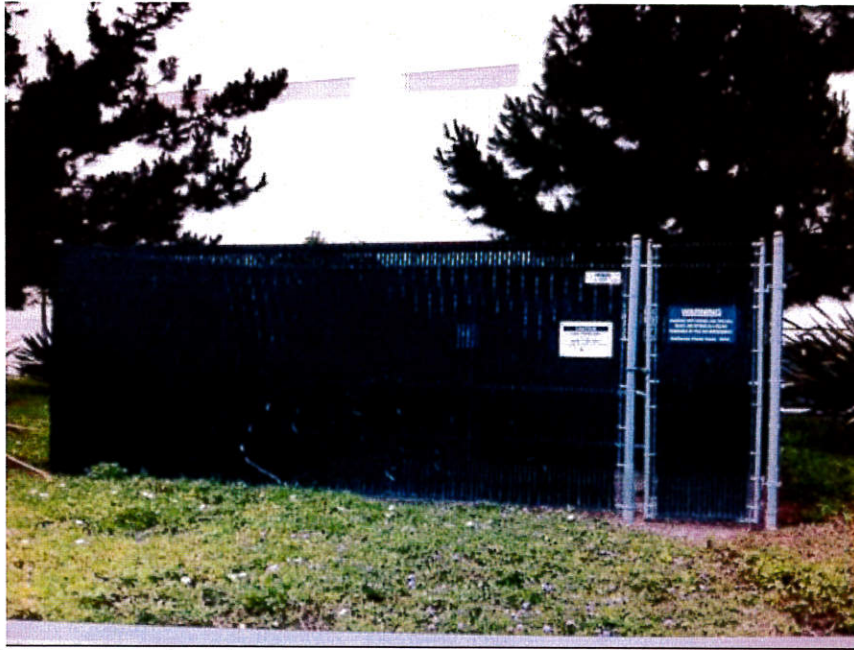
Raymer and Gilbert DRS, the day after the CPUC inspection
